**Noise from the timing belt drive, timing belt jumps or is torn, engine damage.
Timing belt kits CT1168K1/K2/WP1/WP2/K6PRO/WP8PRO.
VW, Audi, Seat, Skoda 1.4–2.0 TDI common rail, EA288**

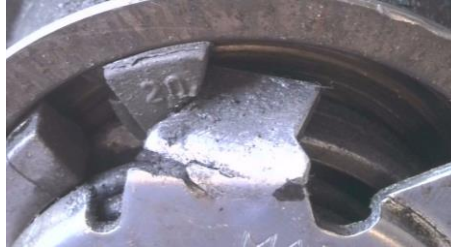
Fig. A

Noise from the timing belt drive, timing belt jumps or is torn, stop tab on tensioner pulley cracked or broken off (**Fig. A**). Signs of high surface load on the back of the belt (**Fig. B**) and on the running surfaces of the pulleys. Defective/blocked pulley bearings.

This leads to abnormal oscillation of the tensioner pulley and impermissible levels of tension in the belt drive. The belt drive overheats as a result and starts to make noises. Recurring impact with the stop face causes the stop tab to break (**Fig. A**).

Carry out tensioning/fitting in accordance with the vehicle manufacturer's instructions.

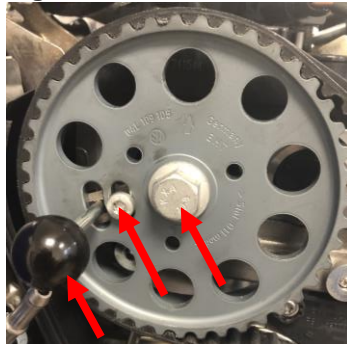
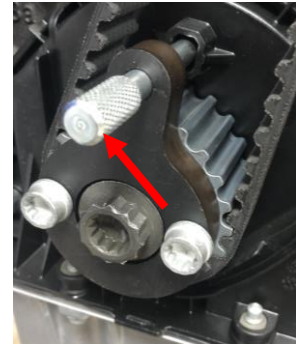
Fig. C

When tensioning the toothed belt drive, it is not only important to pin the shafts, but also to loosen the camshaft sprocket and the high-pressure pump sprocket (**Fig. C and D**). In addition, it must be ensured that the high-pressure pump sprocket is correctly positioned (**Fig. D**). If this is not done the belt tension will not be distributed over the entire belt drive
